Dust Reduction (Sugar)

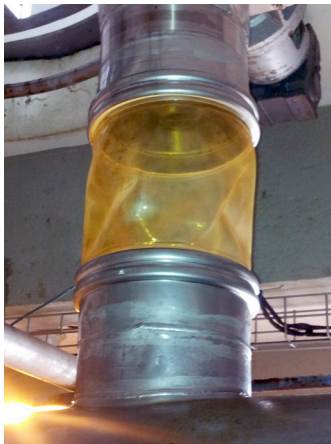
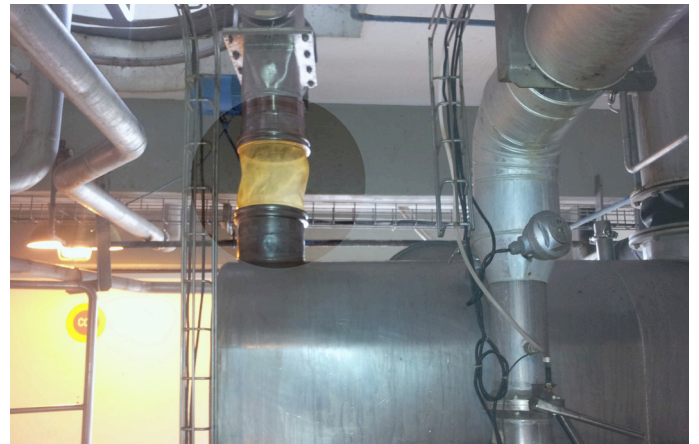
A coned flow-correction ring was installed on the rotary sifter to help reduce abrasion on the connector by directing sugar away from the fitting. A standard length BFM® Seeflex fitting was used with an increased diameter to accommodate for the sifter throw.

In addition to the much cleaner, dust free environment, the connector life has been increased from 5 days to 9 months - a substantial saving in downtime and maintenance.
