Explosion Risk Reduction (Construction Additives)

Health and safety is paramount for global chemicals manufacturer AkzoNobel at its Elotex plant in Geleen, the Netherlands, but the construction additives produced at this plant involve fine, abrasive powders which were proving hard to contain. The resultant dust leakage posed a real explosion risk. After installing a BFM® fitting system on their sifter, AkzoNobel were so impressed with its performance they are gradually replacing all of their connectors with BFM®.

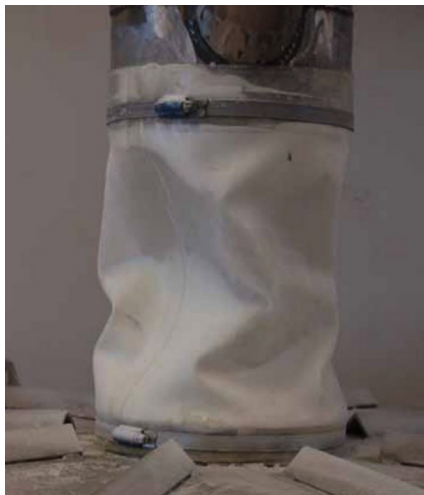
BEFORE

Fine, abrasive powders, combined with a pneumatic conveying system, meant that even small tears or gaps in the traditional clamped flexible connectors at the plant caused dust leakage.

The hose-clamp seals did not perform well under pressure, and with 25 different fittings, manual error with installing the existing clamp & hose connectors to the incorrect length also added to the leakage problems.

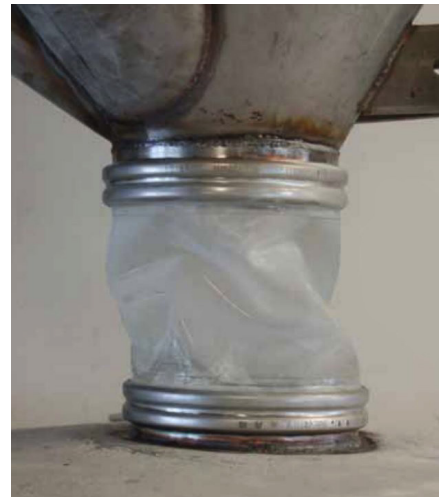
AFTER

After an initial trial BFM® fitting system was installed in the most challenging position on the sifter, the seal was so superior that AkzoNobel are now replacing all 25 flexible connectors with BFM® fitting. There is no longer dust leaking into the plant, and this has significantly reduced the risk of explosion.

As the connectors are replaced, the pipes and spigots are being adjusted to standardize the sizes, helping to reduce the inventory and multiple suppliers.

Replacement is also now fast and easy with no possibility of incorrect installation.
